NATIONAL DAM INSPECTION PROGRAM. JEANNETTE DAM (NDSI.D.-PA-0048--ETC(U)

PHASE I REPORT
NATIONAL DAM INSPECTION PROGRAM

Jeannette Dam: NDS I.D. No. PA-00486

Owner: Mrs. Helen Indyk 12 104p.
State Located: Pennsylvania (PennDER I.D. No. 65-9)
County Located: Westmoreland
Stream: Tributary of Brush Creek
Inspection Date: 9 March 1979 11 Apr 79
Inspection Team: GAI Consultants, Inc.
570 Beatty Road
Monroeville, Pennsylvania 15146

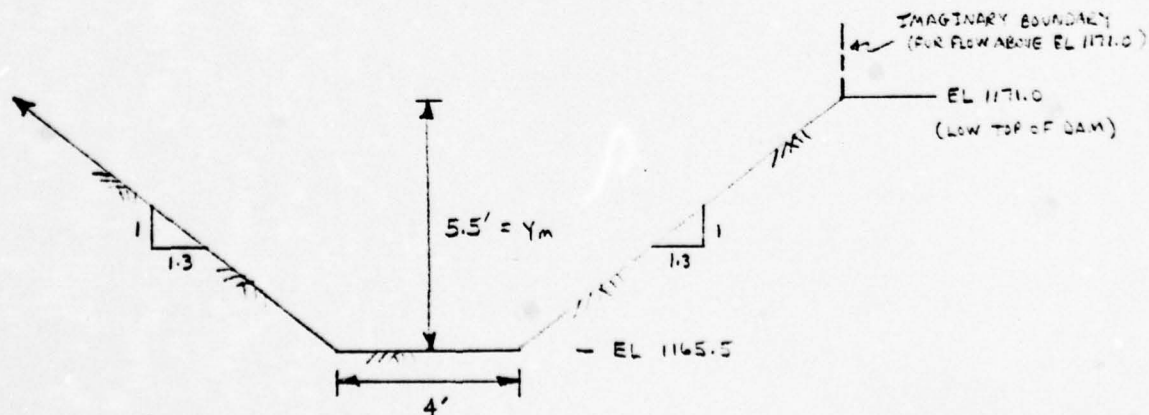
THE CONTROL SECTION IS VERY UNSTABLE SINCE IT IS
 FOUNDED IN EARTH AND IS A PRODUCT OF THE EROSION
 AROUND THE ACTUAL SPILLWAY STRUCTURE. HOWEVER, IT WILL
 BE ASSUMED THAT THE SECTION IS STABLE IN THIS ANALYSIS.

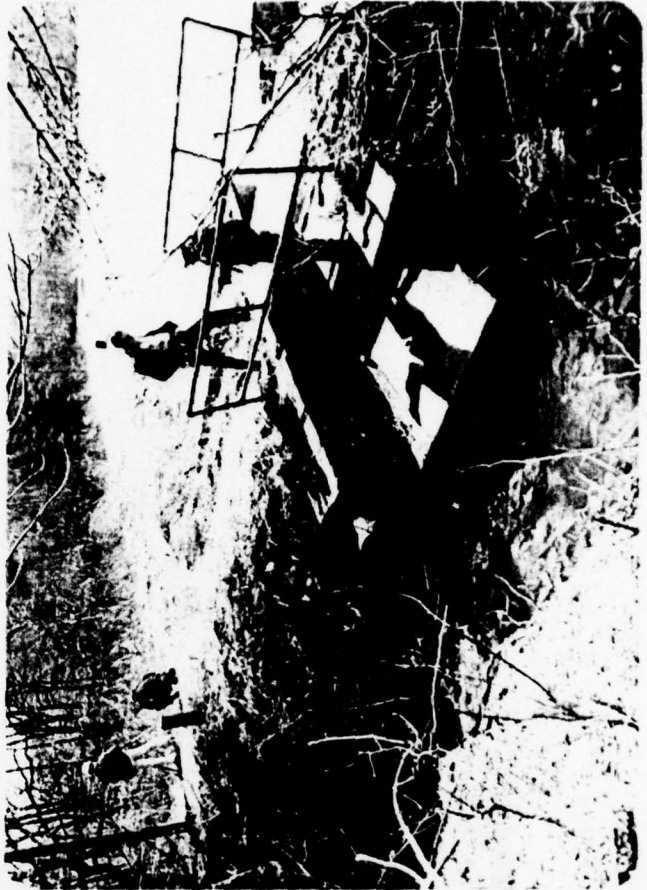
The small channel spillway located between the reservoir and diversion channel is shown in Photograph 4. As indicated, the end of the spillway adjacent to the diversion channel has settled and cracked apparently as a result of undercutting. Under low flow conditions, discharge actually passes under the structure and into the diversion channel, further undercutting the slab. The downstream masonry wall has cracked beneath the wood plank walkway and has also rotated several inches.

PHOTOGRAPH 4 View of the emergency spillway structure and diversion channel located along the west shore of the lake approximately 35 feet from the embankment crest.

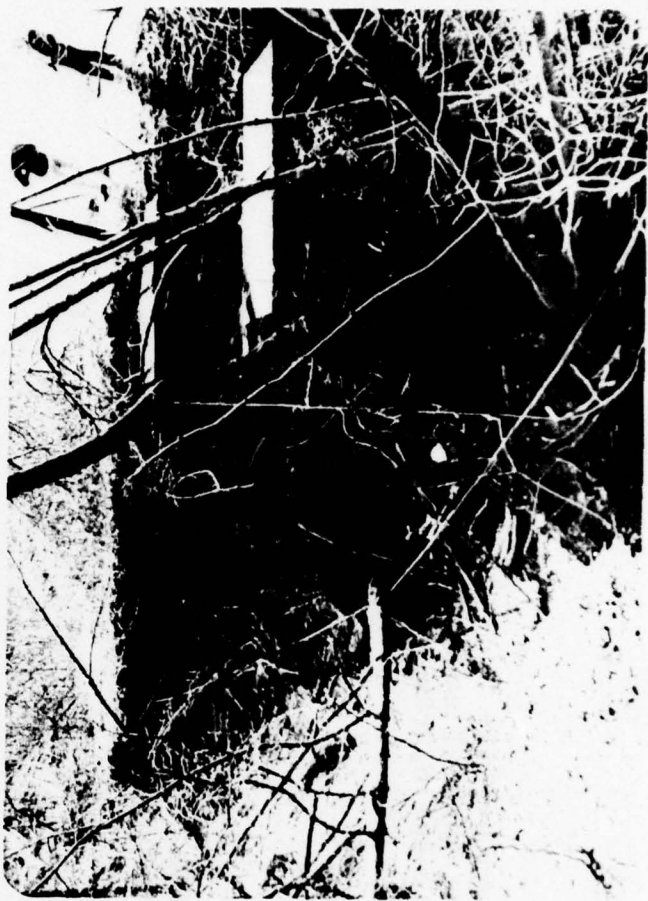
8

The erosion gully along the left abutment-embankment contact has resulted from the apparent clogging and malfunctioning of the drop-inlet spillway system (see Figure 2 and Photographs 5 through 8). This deficiency is most serious and actually threatens the stability of the entire embankment. Minor deficiencies include a general neglect of embankment maintenance and a small seep along the right abutment. The downstream slope was strewn with litter and overgrown with bushes and small trees. The seep at the right abutment emanates from about mid-height of the embankment and has been noted in previous inspection reports as early as 1915.

The condition of the original drop-inlet structure is shown in Photographs 7 and 8. The extent of erosion and deterioration is readily discernible when compared with Photograph 6 taken in 1915. Approximately 16 feet of soil has been eroded from all sides of the structure to the extent that the foundation is being undercut along its left corner, seriously endangering its stability. The erosion also threatens the stability of the embankment and its natural soil foundation in the area of the inlet structure and along the left abutment-embankment contact.

View looking downstream along the eroded spillway discharge channel. The majority of the channel appears to be cut into natural ground immediately below the downstream embankment toe.

c. Remove entirely the old masonry drop-inlet structure located at the left abutment. The inlet conduit should be disconnected prior to removal of the spillway and sealed at all exposed ends (including those observed in the hole at the downstream toe).

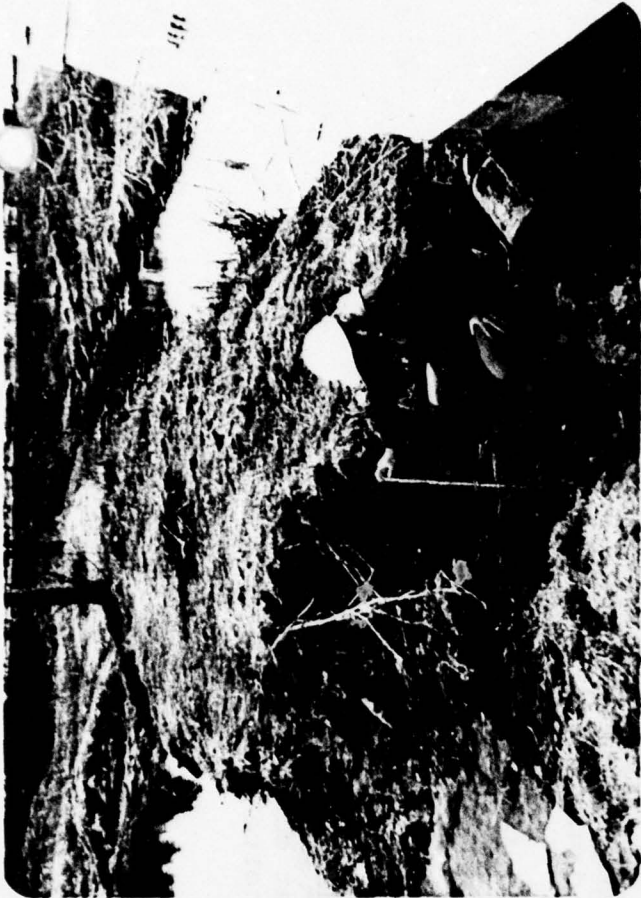
10

1. Diversion Channel. Aside from the breached dike shown in Photograph 10, the diversion channel upstream of the spillway structures is in good condition. It is, however, in need of general maintenance to clear channel obstructions and partially plugged culverts.

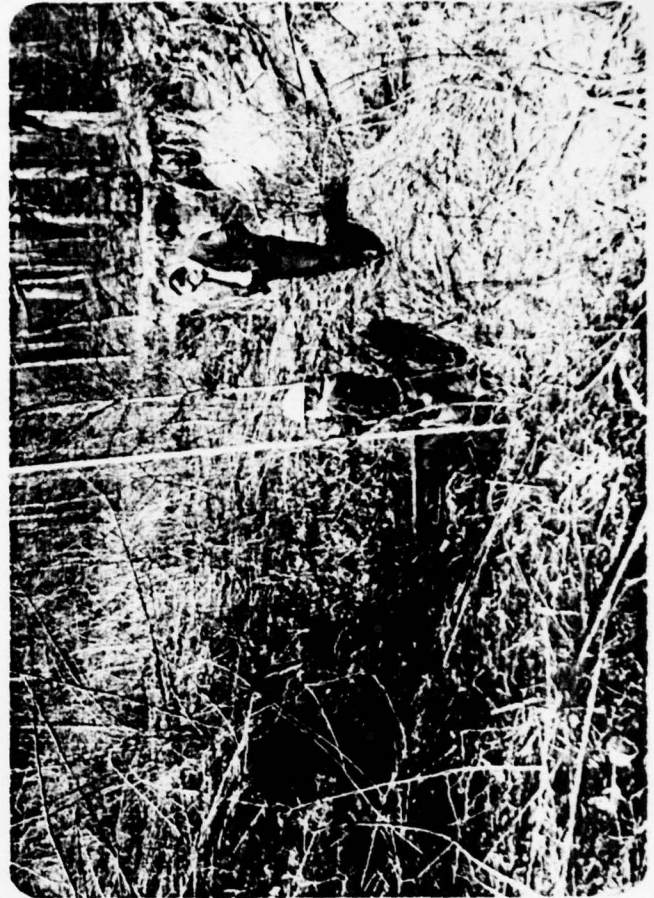
12

A large hole, possibly excavated to expose a broken pipe, was observed at the downstream toe about 150 feet from the left abutment. This is considered a significant deficiency as it presents a local weak area within the embankment where further problems are likely to occur. Since no evidence of seepage, piping, or slope failure were observed in this area during the inspection, it is not considered an immediate threat to embankment stability. Nevertheless, the condition is undesirable.

View of a large hole located along the downstream face of the embankment approximately 150 feet to the right of the drop-inlet spillway.

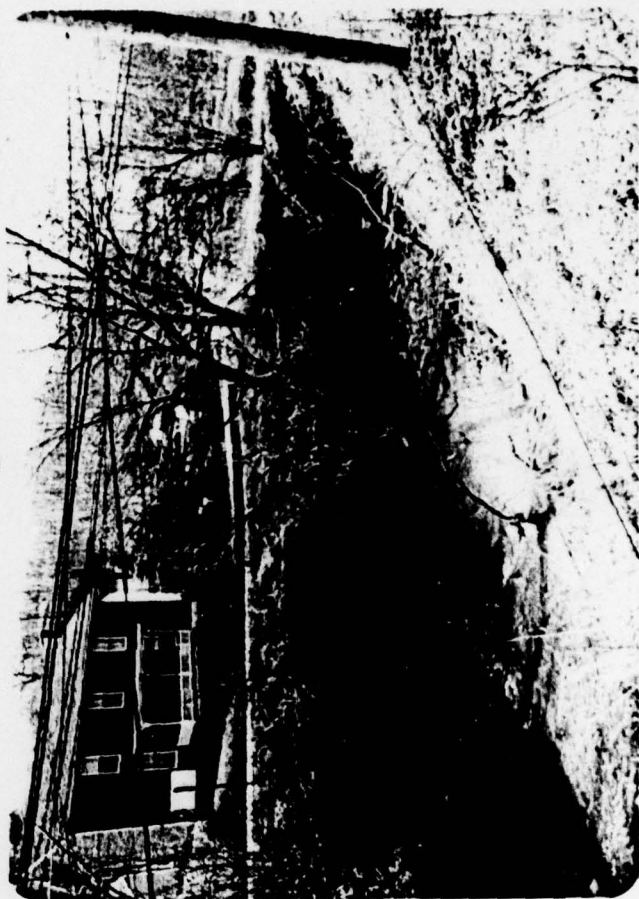
16

View of culvert that restricts downstream flow and several dwellings that could be affected by a failure of Jeannette Dam.
